MINERALOGICAL ALTERATIONS OF SOIL IRRIGATED WITH ACIDIC MINE WATER IN THE ALAMOSA RIVER BASIN

Colorado State University,

Department of Soil and Crop Sciences

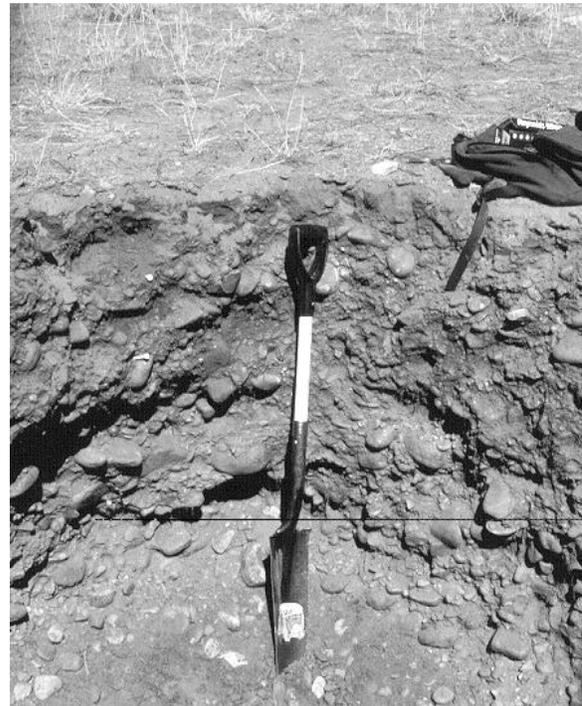
Ap-- 0 to 23 cm; very gravelly sandy clay loam; brown (7.5YR 4/3) moist; weak fine granular structure; soft, very friable, slightly sticky and non plastic; common fine roots throughout; no effervescence; 30% gravels; 5% cobbles; clear wavy boundary.

Bt--23 to 42 cm; very gravelly sandy clay loam; brown (7.5YR 4/4) moist; weak subangular blocky structure; soft, very friable, slightly sticky and non plastic; common fine and few very fine roots throughout; no effervescence; 50% gravels, 5% cobbles; clear wavy boundary.

2Bck1--42 to 81 cm; extremely gravelly sand; brown (7.5YR 5/4) moist; single grained; loose; non sticky and non plastic; common fine roots throughout; carbonates - none in matrix, pendant coatings on clasts; slight effervescence; 60% gravels, 25% cobbles; clear wavy boundary.

2Bck2--81+ cm; extremely gravelly sand; brown (7.5YR 4/2) moist; single grained; loose non sticky and non plastic; few very fine roots throughout; carbonates - none in matrix, pendant coatings on clasts (slightly greater concentration than 2Bck1); slight effervescence; 70% pebbles, 10% cobbles; gradual wavy boundary.

Figure 2. Site 2 - pre-1984 soil profile.

The degree of weathering in the Graypoint series differs according to which of the six different management schemes the soil is under. Under virgin conditions (site 1), soil formation and weathering are assumed to occur at natural rates typical of arid environments. These weathering processes have slowly developed an argillic horizon from illuviation of clay from the surface. Carbonates have accumulated on the undersides of rock clasts at and below 34 cm with increasing concentration down the soil profile. There are no carbonate concretions in the matrix. The rocks identified from this site show comparatively moderate weathering rinds and are still intact. Site 2 (irrigated and cultivated prior to but not after 1984) also has an argillic horizon and the remnants of a plowed surface horizon which has been subjected to severe disturbance and possible erosion. Carbonates are absent in the upper portion of the profile but can be found on the undersides of rock clasts at and below 42 cm as in site 1. The rocks identified from this site show larger weathering rinds than in site 1 and have some oxide staining but still are intact.

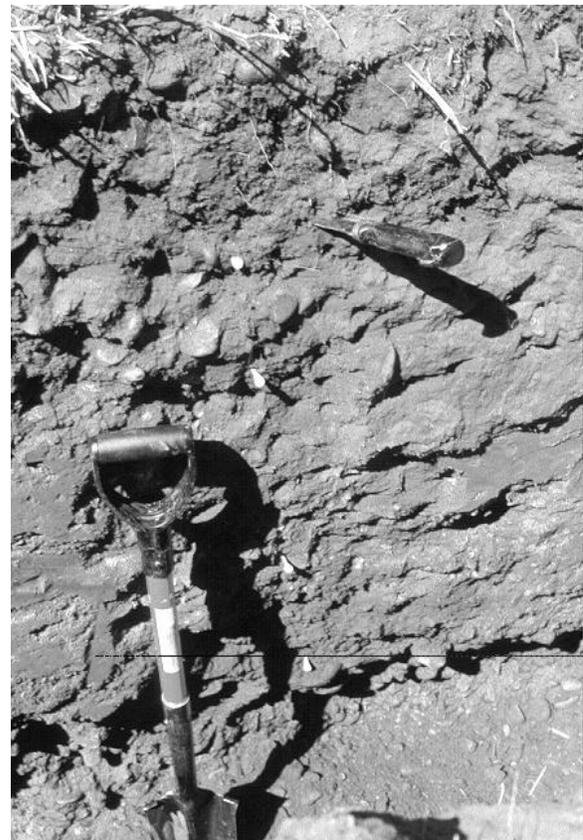
Ap--0 to 28 cm; gravelly sandy clay loam; reddish brown (5YR 4/3) moist; weak fine granular structure; slightly hard, friable, slightly sticky and slightly plastic; common very fine roots throughout; no effervescence; 25% gravels, 5% cobbles; abrupt smooth boundary.

Bw1--28 to 57 cm; extremely gravelly sandy loam; reddish brown (5YR 4/3) moist; single grained; loose; non sticky and non plastic; few very fine roots throughout; no effervescence; 70% gravels, 3% cobbles; clear smooth boundary.

Bw2--57 to 79 cm; extremely gravelly loam; yellowish red (5YR 5/6) upper half of the horizon and reddish brown (5YR 4/3) moist; single grained; soft, very friable, slightly sticky and non plastic; common medium and very fine roots throughout; no effervescence; 65 % gravels, 3% cobbles, 5% stones; clear wavy boundary.

2Bw3--79 to 108 cm; extremely gravelly sand; dark reddish brown (5YR 3/3) moist; single grained; loose; non sticky and non plastic; few fine roots throughout; iron and manganese staining on coarse fragments; no effervescence; 80% pebbles, 5% cobbles; gradual wavy boundary.

2Bw4--108+ cm; extremely gravelly sand; dark brown (7.5YR 3/2) moist; single grained; loose; non sticky and non plastic; few very fine roots throughout; very thin carbonate coatings on coarse fragments (unreactive) no effervescence; 70% pebbles, 20% cobbles.

Figure 5. Site 5 - Alamosa flood irrigated soil profile.
