The Alamosa River Irrigation System Western Central San Luis Valley, Colorado

By
Susan Ford and David Skidmore
Morrison Knudsen Corporation
7100 E. Belleview Avenue, Suite 300
Englewood, CO 80111

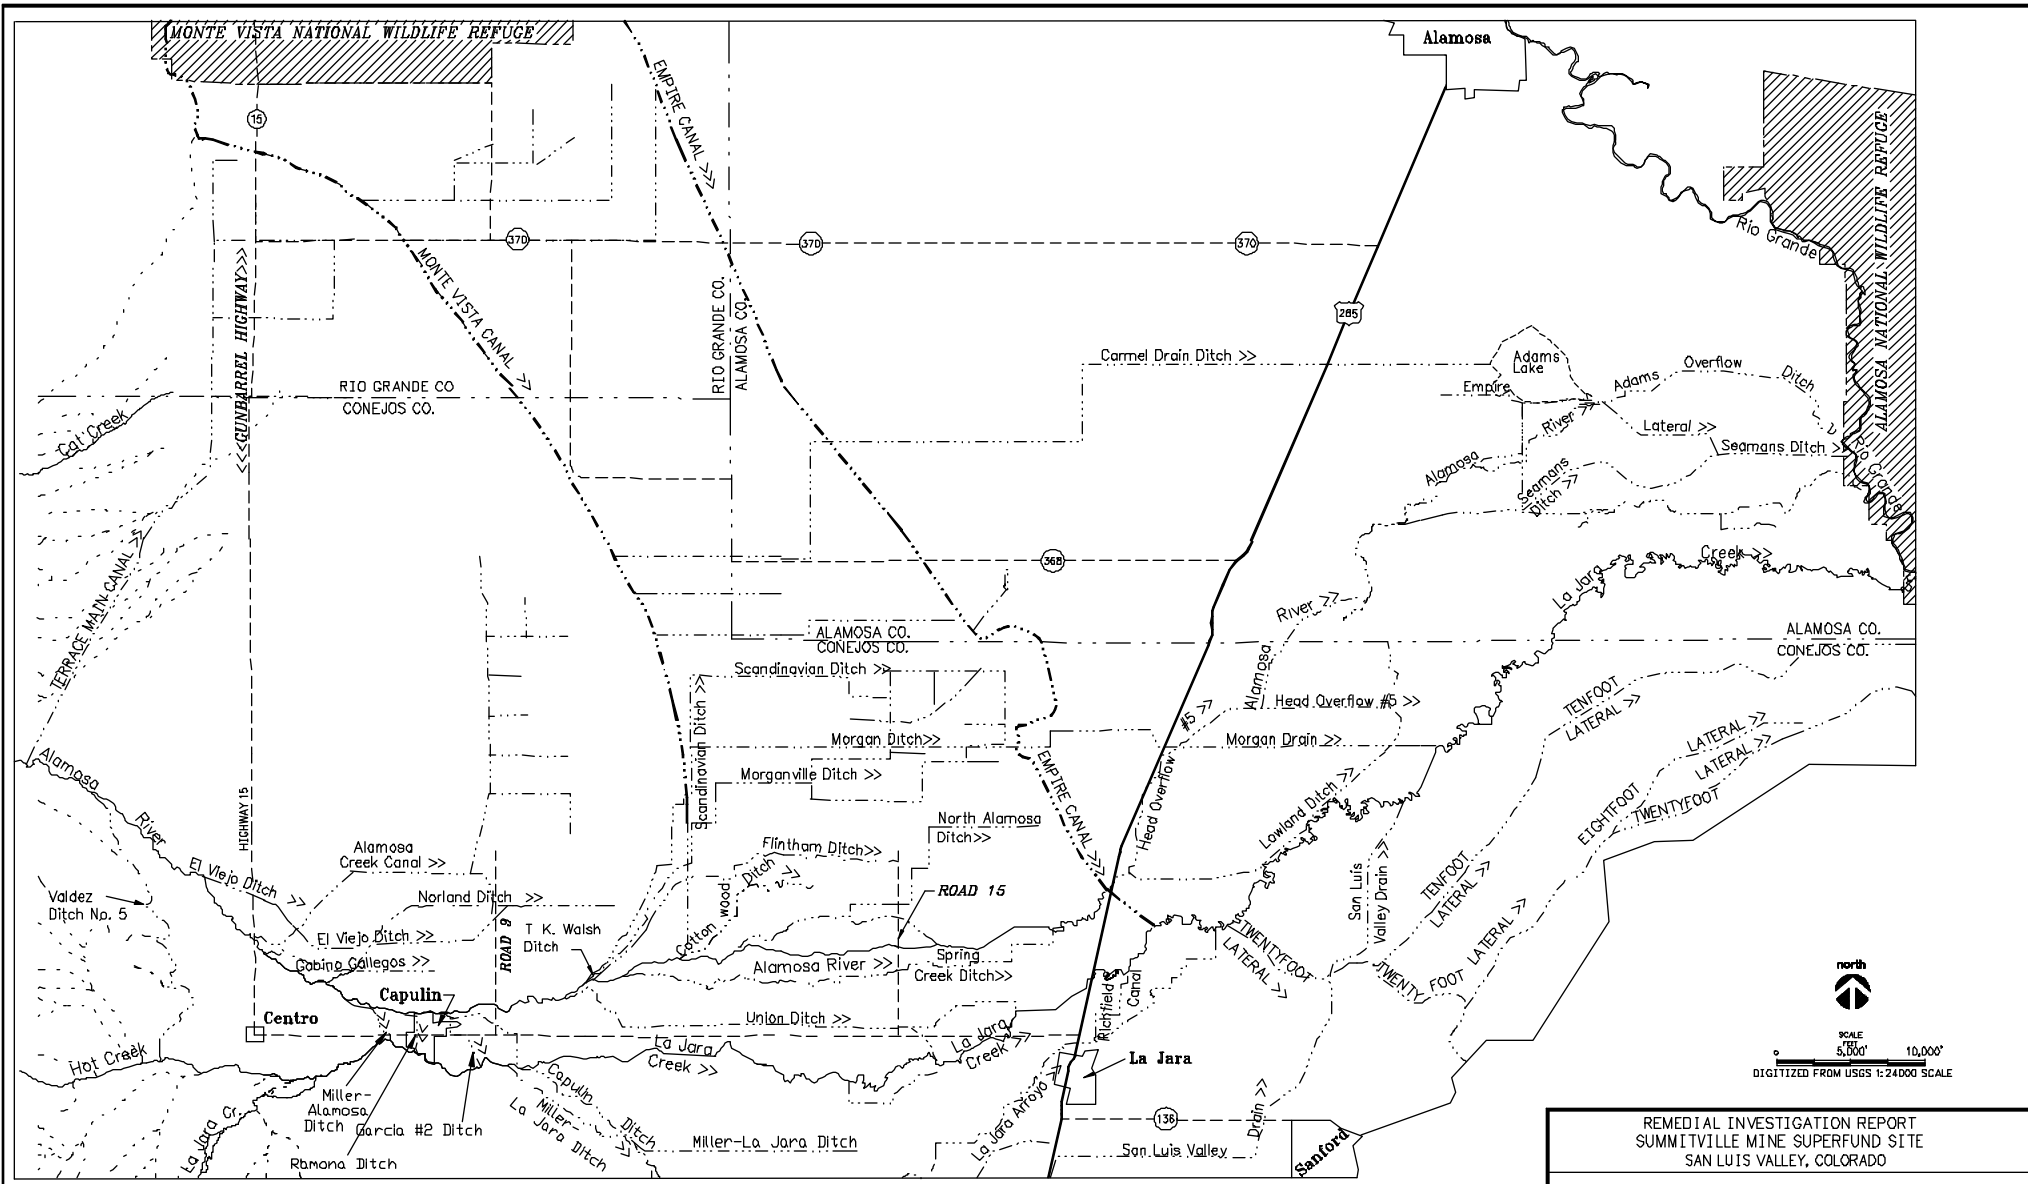
REMEDIAL INVESTIGATION REPORT SUMMITVILLE MINE SUPERFUND SITE SAN LUIS VALLEY, COLORADO			
Figure 1 CURRENT UNDERSTANDING WESTERN CENTRAL SAN LUIS VALLEY IRRIGATION SYSTEM			
ARCS Regions VI, VII, VIII US Environmental Protection Agency			
MORRISON KNUDSEN CORPORATION			
FILE NAME (GAD) O12HO27A.DWG		DATE: 5/13/96	
WORK ORDER	TASK	DRAWING NUMBER	REV. DRIVE
3780-2718	122H	FIGURE 1	A P:

Thirty of these diversion structures are located west of Hwy 285, which runs north-south between Antonito and Alamosa (see Figure 1). The size of these ditches ranges from the Terrace Main Canal, a truncated triangular ditch approximately 6 feet wide and 3 feet deep, to the San Jose No. 2, a small channel approximately one foot wide and eight inches deep. The volume of water carried in these ditches varies from a twelve-year average of 33.40 cubic feet per second (cfs) in the Terrace Main Canal to a twelve-year average of 1.47 cfs in the San Jose No. 2 (see Table 2). These diversions direct water north and south of the Alamosa River.

³Water chemistry is measured sporadically at AR-31.0 and along the divisions. See Figure 1 for locations.

During a reconnaissance in April 1995, it was noted that a large stretch of the Alamosa River was dry. Water was noted where the Gunbarrel Highway (Hwy 15) crosses the Alamosa River north of Centro. However, at Road 9 just east of Capulin, the Alamosa River was dry (see Figure 1). At Road 15 approximately six miles east of Road 9, the Alamosa River again contained water. Water with an approximate pH of 5.7 was present in the Alamosa River just west of Road 9. However, at Road 15 (approximately six miles east of Road 9) water was present in the Alamosa River and had an approximate pH of 6.7. It is probable that the water at Gunbarrel Highway is not chemically similar to the water present at Road 15. It is unknown how often segments of the Alamosa River are dry (MK, 1995).

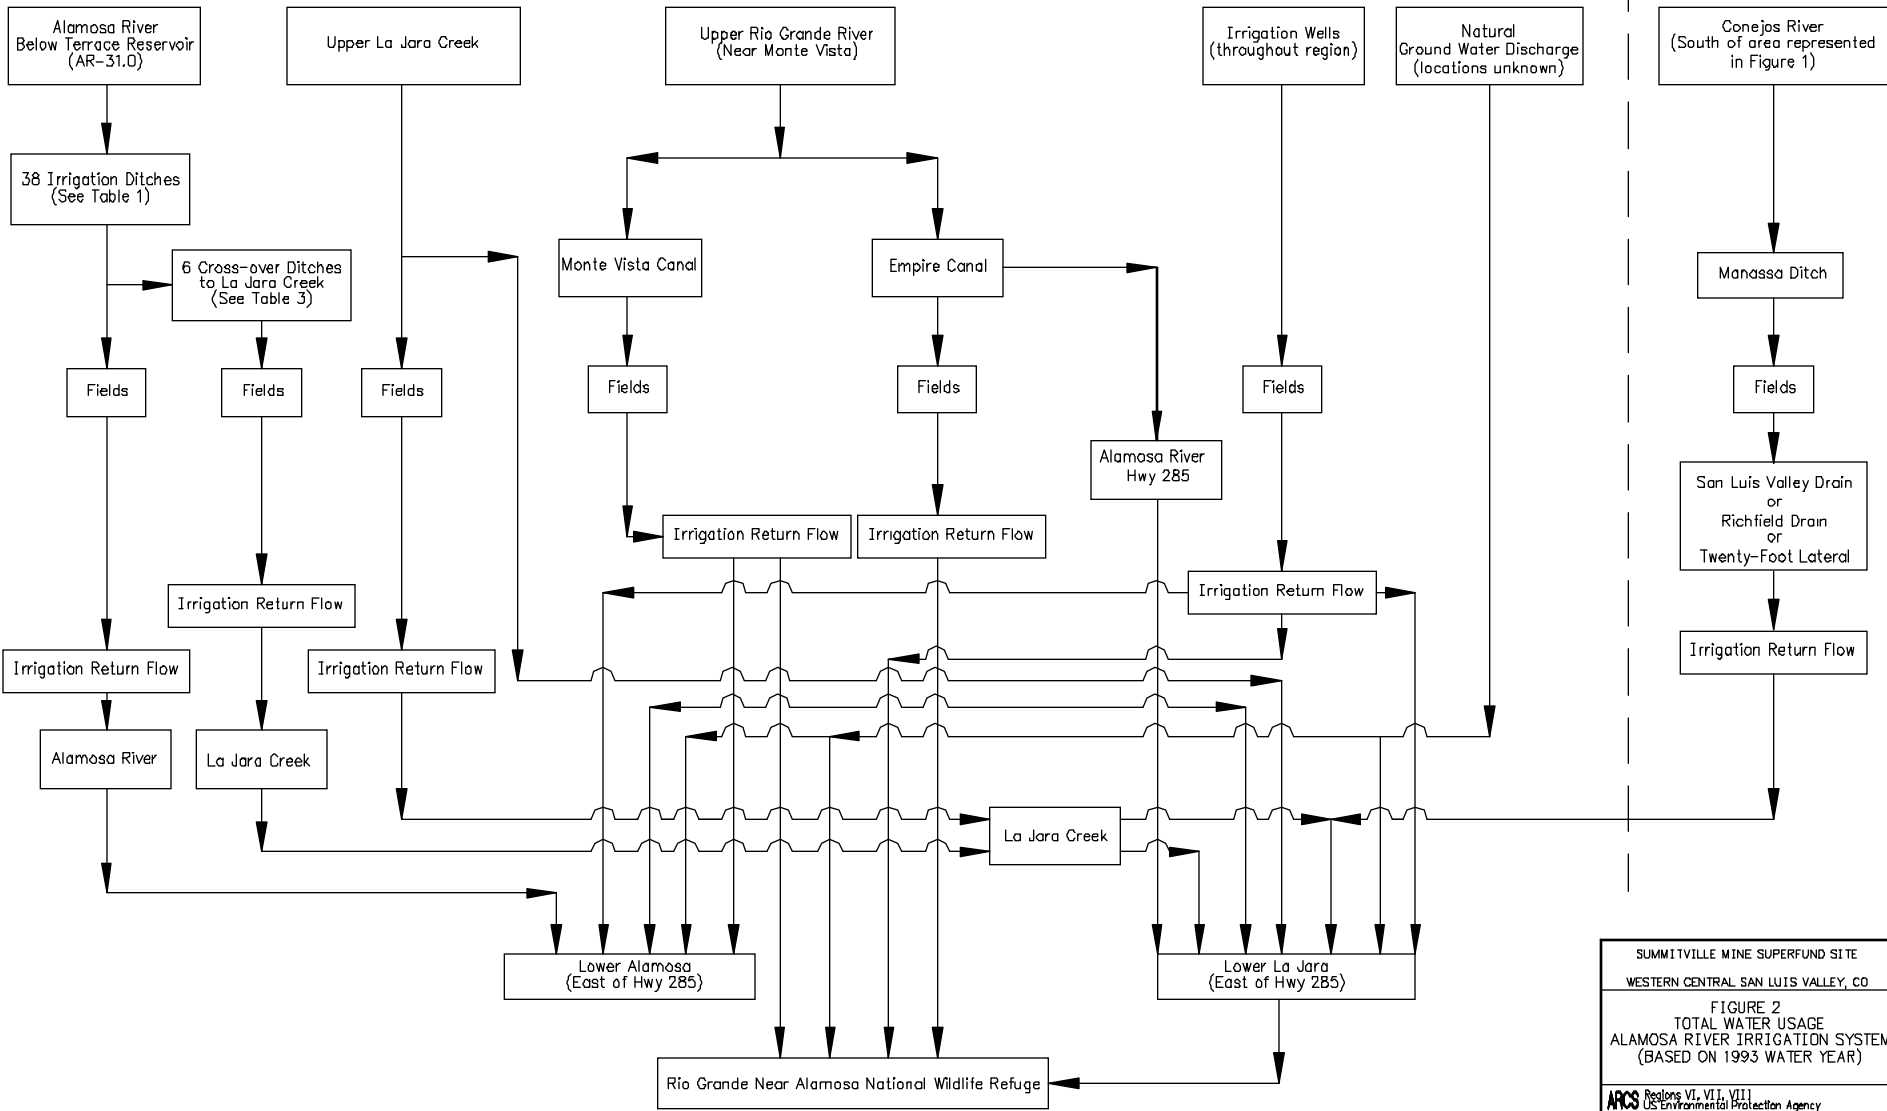
WATER SOURCES IN WESTERN CENTRAL SAN LUIS VALLEY

SUMMITVILLE MINE SUPERFUND SITE
 WESTERN CENTRAL SAN LUIS VALLEY, CO
 FIGURE 2
 TOTAL WATER USAGE
 ALAMOSA RIVER IRRIGATION SYSTEM
 (BASED ON 1993 WATER YEAR)

from ground water to the Alamosa River also occurs. Additional discussion of these intersections follows in Nature and Extent Section. Figure 2 presents a flow chart of all known water sources in the area and direction of flow.

The irrigated area served by the Alamosa River will be discussed as three categories: the Alamosa River and diversions west of Hwy 285 that do not transfer water to La Jara Creek; diversions west of Hwy 285 that transfer water to La Jara Creek; and the Alamosa River and diversions east of Hwy 285 (See Figure 2).
